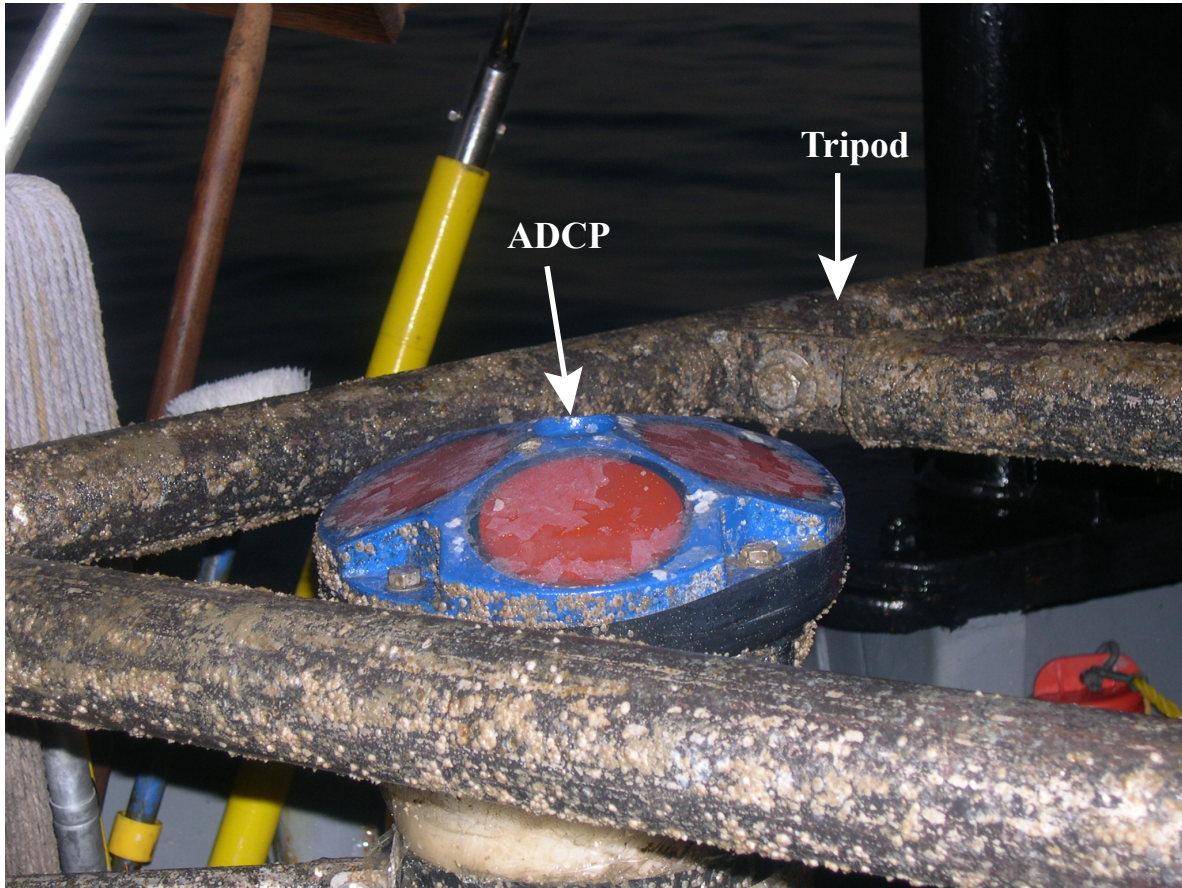
Figure 33. A photograph of the tripod recovered from Site 2 at the end of the second deployment. Biofouling was significantly less during the second deployment, as seen in this photograph where the surfaces of the tripod and the ADCP have minimal fouling.
