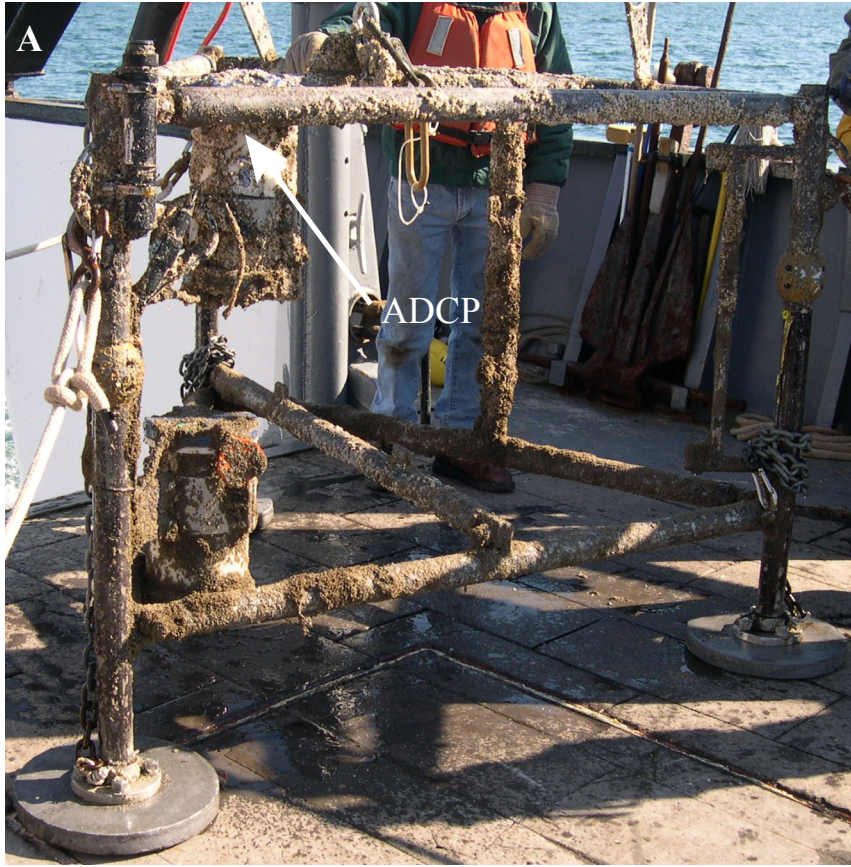
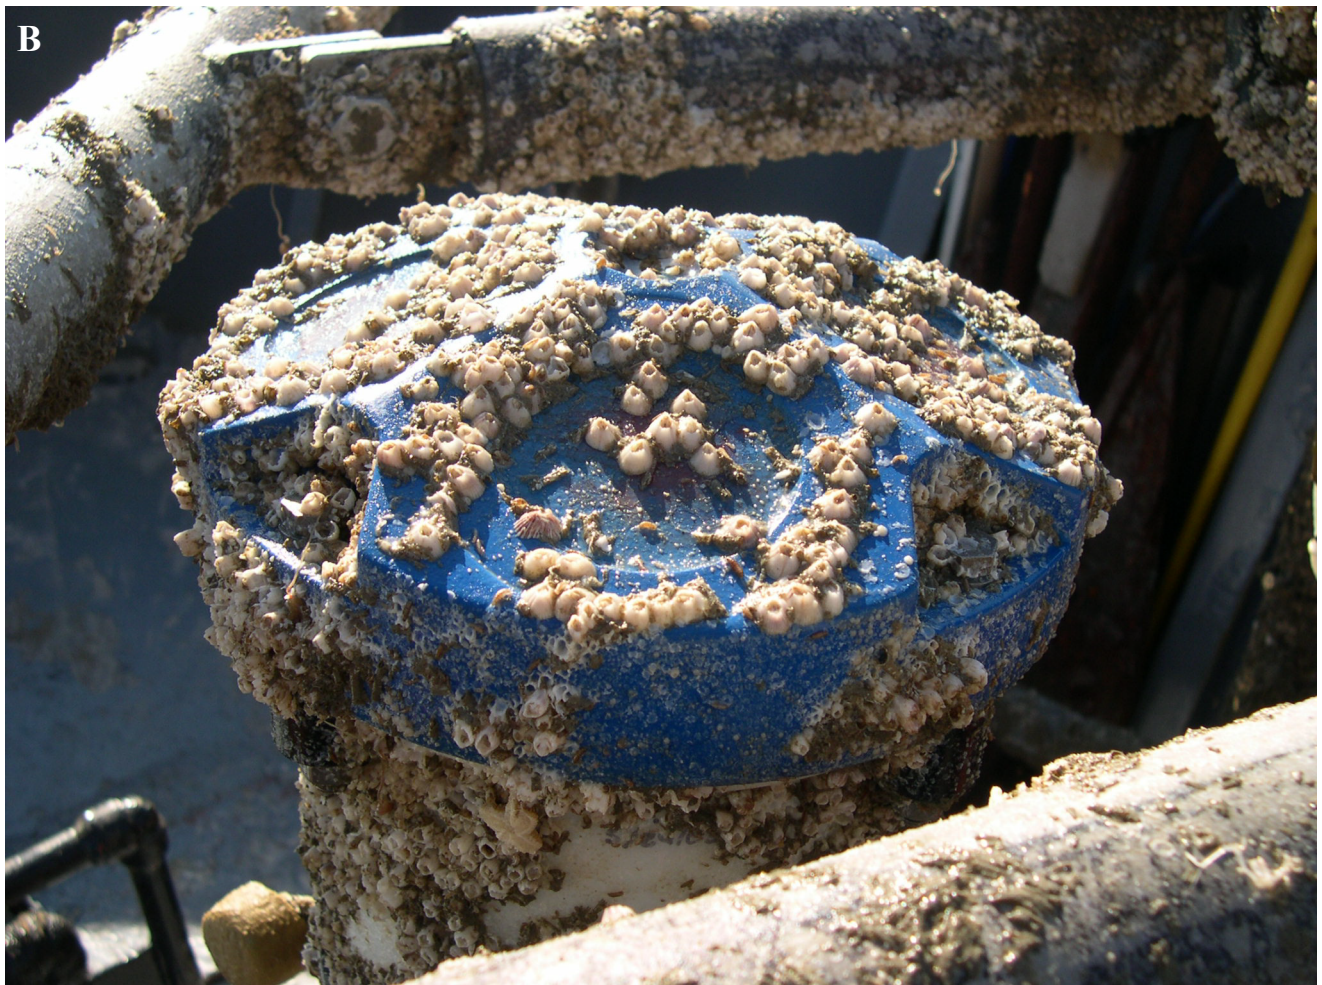
Figure 30. (A) A photograph of the tripod recovered from Site 1 at the end of the first deployment. (B) A photograph of the ADCP mounted to the tripod shown in (A). The ADCP and tripod are both heavily biofouled.
