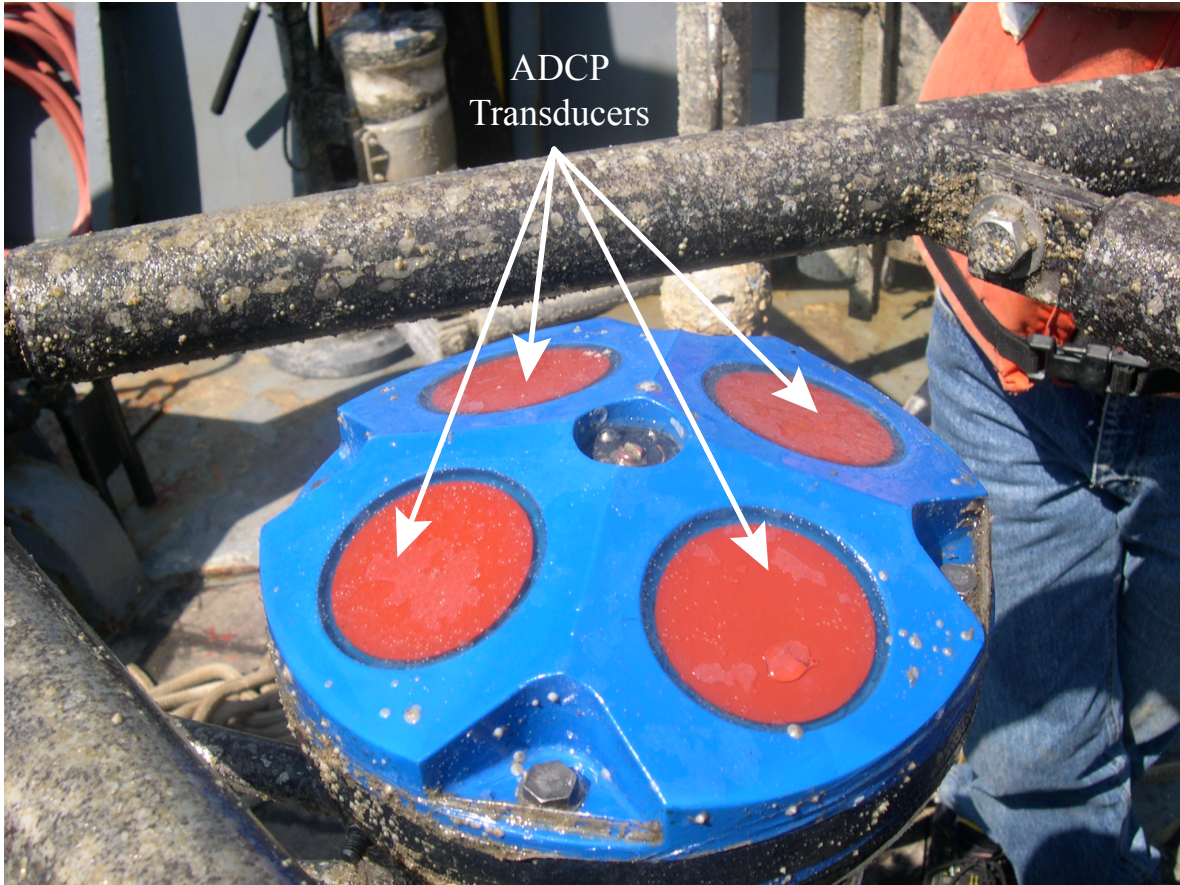
Figure 35. A photograph of the ADCP on the tripod recovered from Site 3 at the end of the second deployment. Biofouling was much less significant during this deployment. The ADCP transducers are free from any biofouling.
