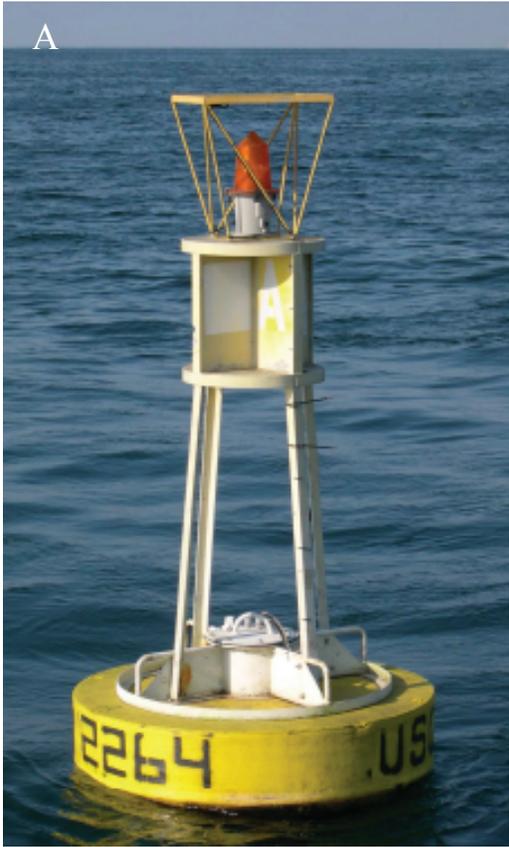
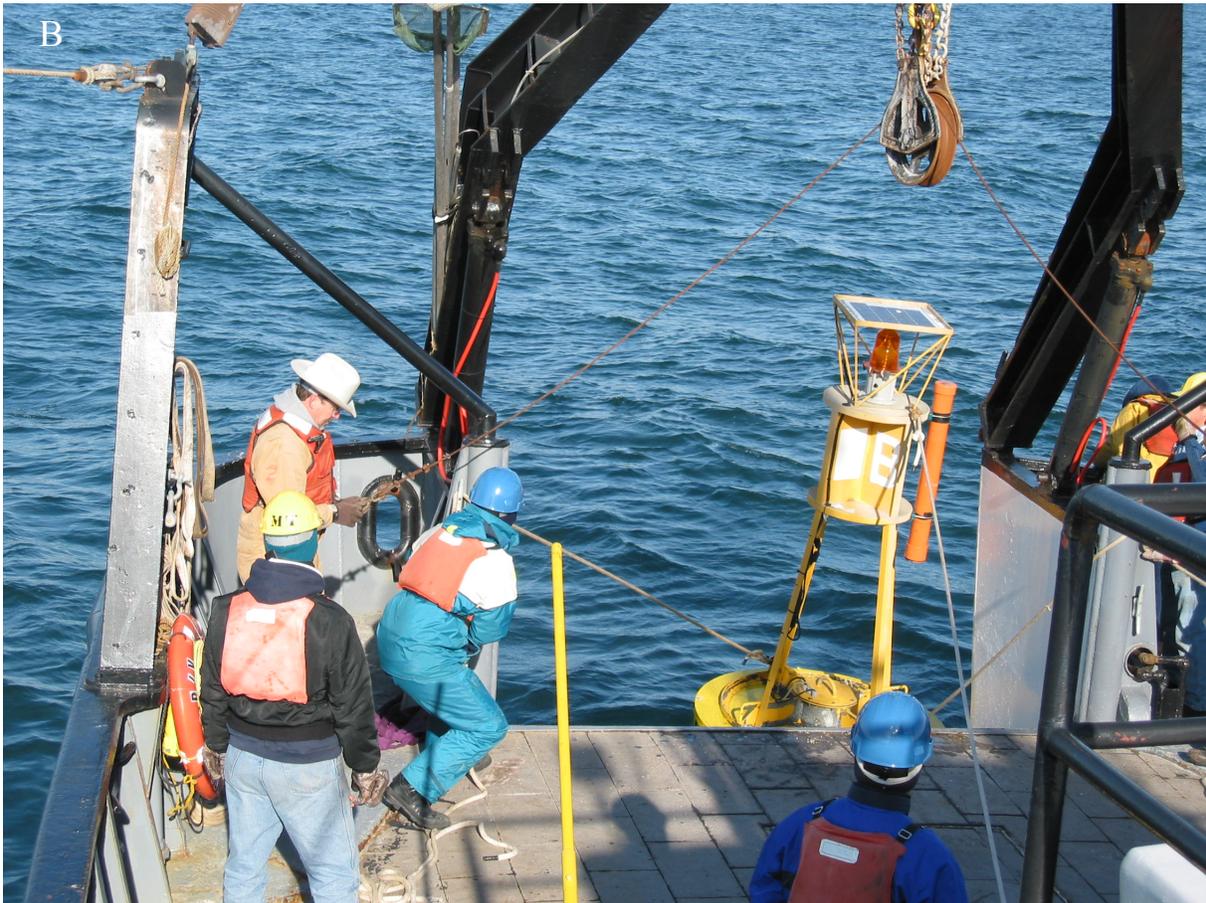
Figure 15. (A) A photograph of a USGS surface buoy. Buoys were deployed adjacent to tripods at sites 1, 2, 3, 6, 7A and 7B to mark the sites and provide protection from trawl fishing. A CT was attached to the buoys deployed at sites 2, 3, and 7A to measure conductivity and temperature 1 meter below the surface. (B) A photograph of the recovery of a USGS surface buoy aboard the Research Vessel *Dan Moore*.
