Historical Shoreline Changes at Rincón, Puerto Rico, 1936-2006

By E. Robert Thieler, Rafael W. Rodríguez, and Emily A. Himmelstoss

Open-File Report 2007-1017

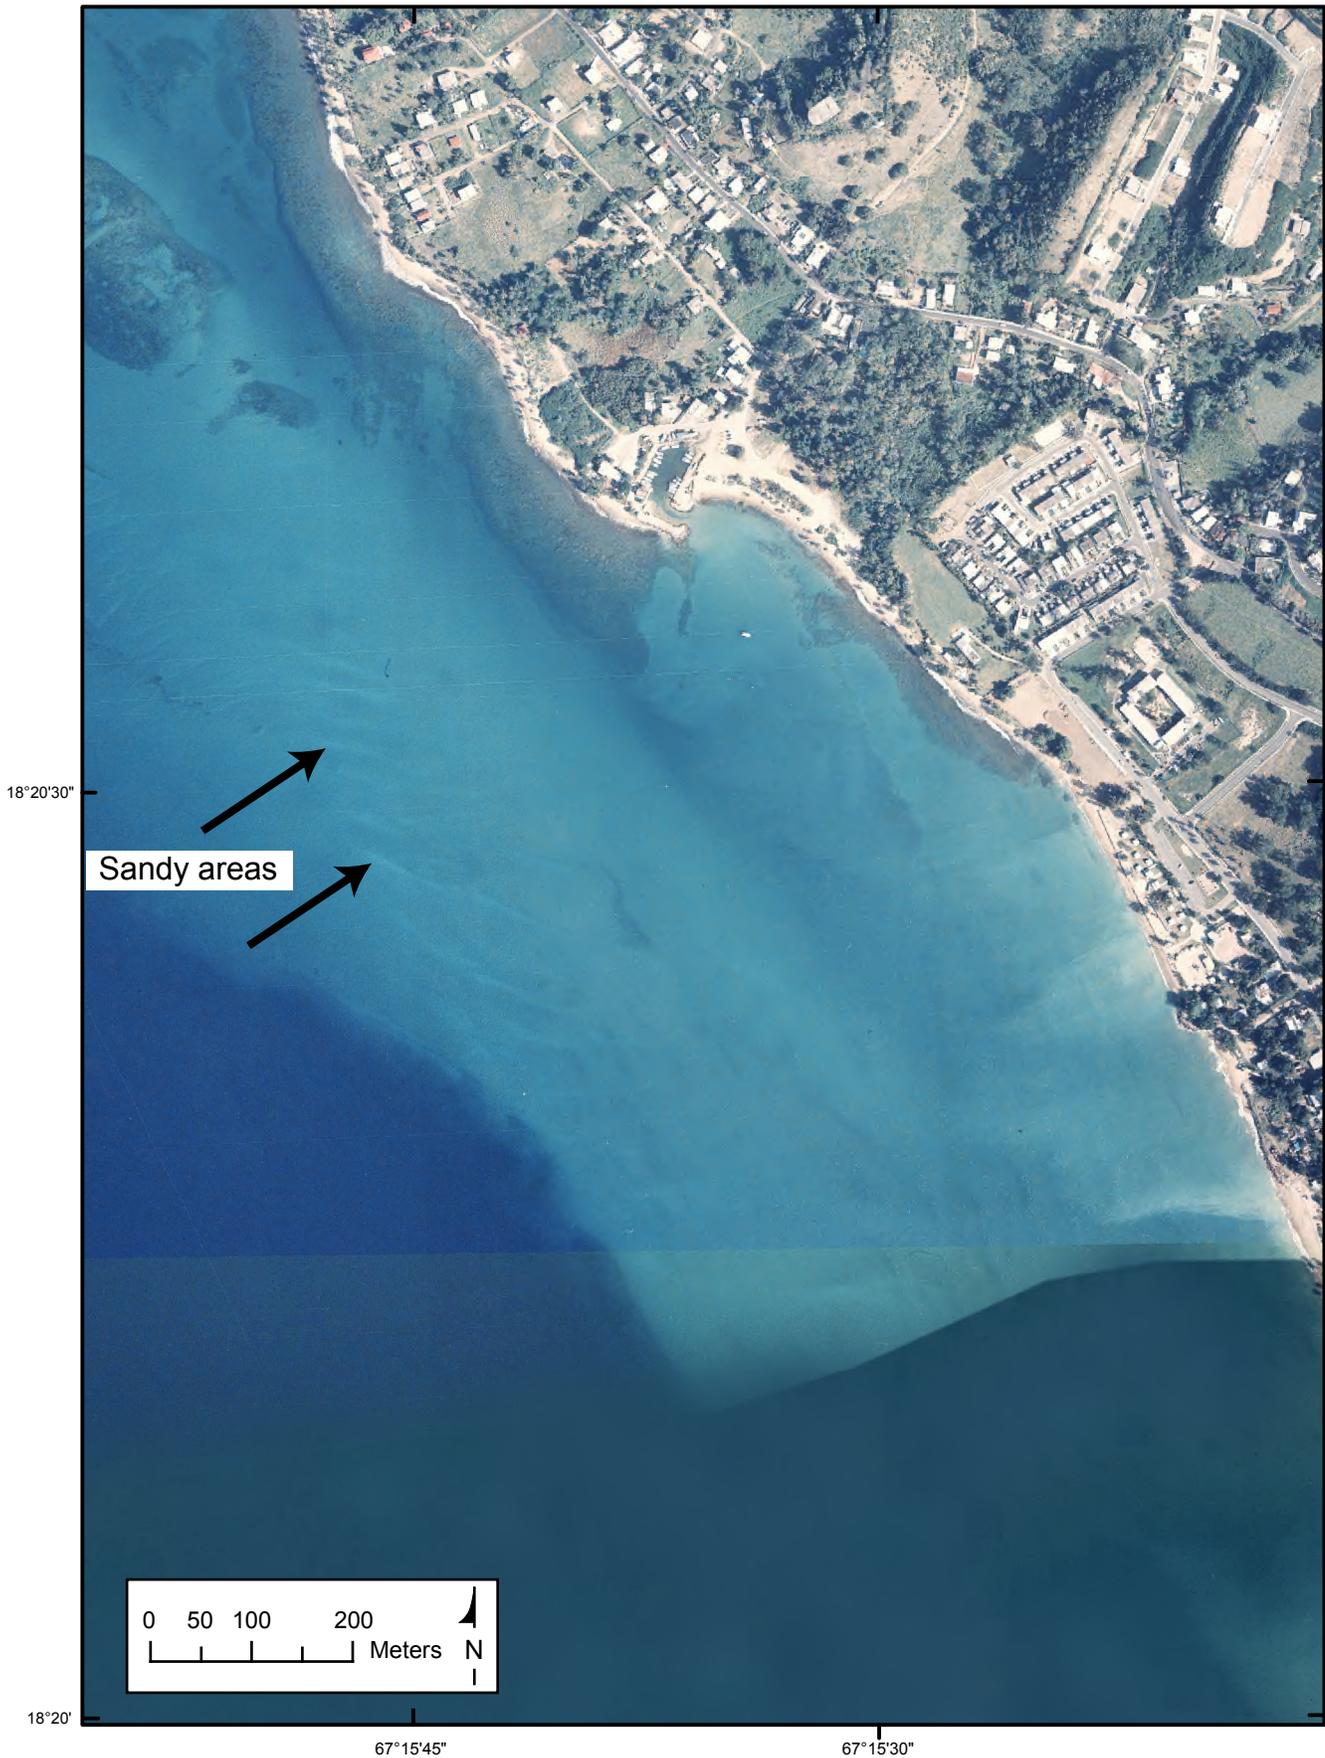
Figure 14. A 1997 orthophotograph showing possible sandy deposits on the shoal feature southwest of Punta Ensenada, Rincón, Puerto Rico. (Photo from Centro de Recaudación de Ingresos Municipales (CRIM) of the Puerto Rico Office of Management and Budget.)

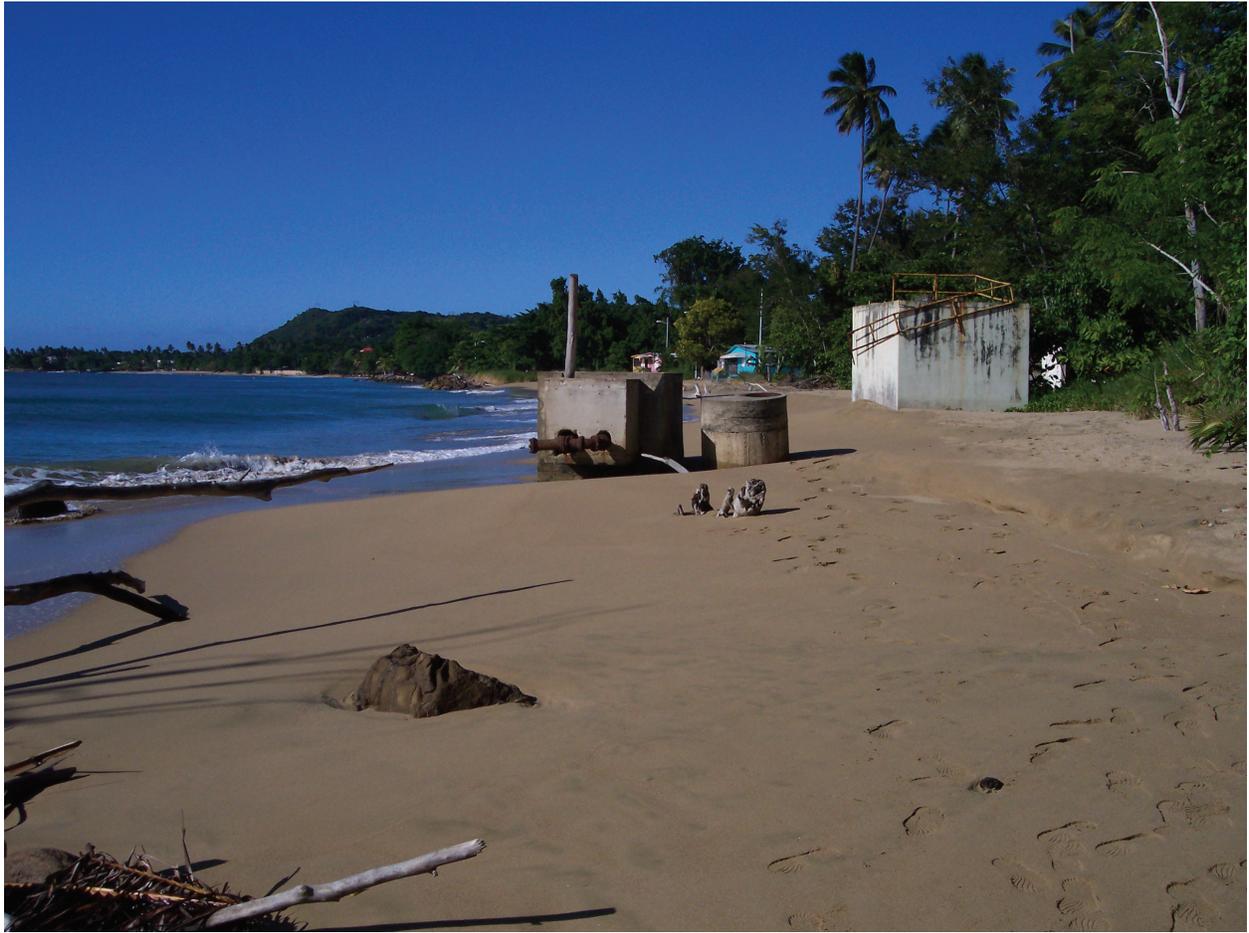
Figure 18. Photograph taken on 05 December 2005 showing infrastructure that is now on the beach and in the surf zone in Reach B-2, Rincón, Puerto Rico, study area.

Reach B-2 (transects 62 through 68/69; fig. 17) shows a fluctuating shoreline through 1977. By 1983, the shoreline had retreated about 50 m from the average position of the 1936-1977 shorelines. Between 1994 and 2006, over 30 m of shoreline retreat occurred at transects 68 and 69, leaving some infrastructure exposed in the surf zone (fig. 18).

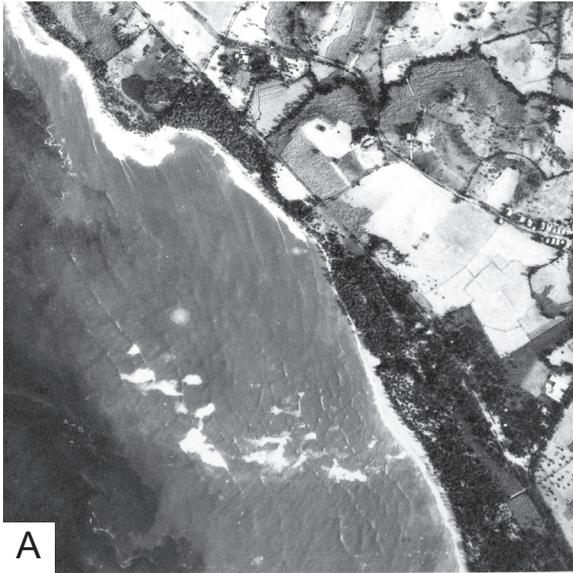
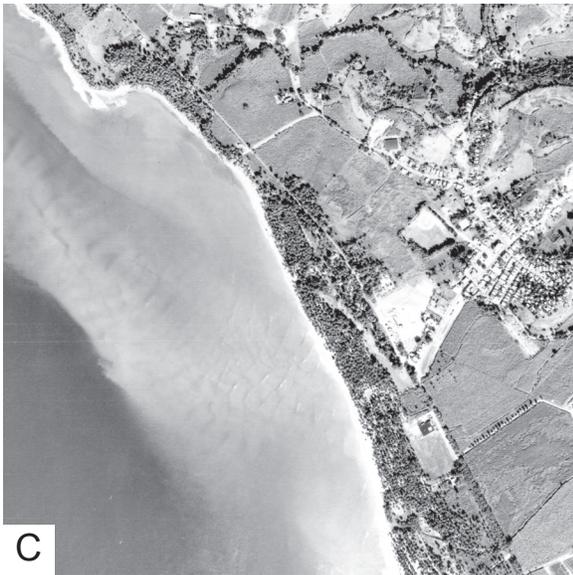
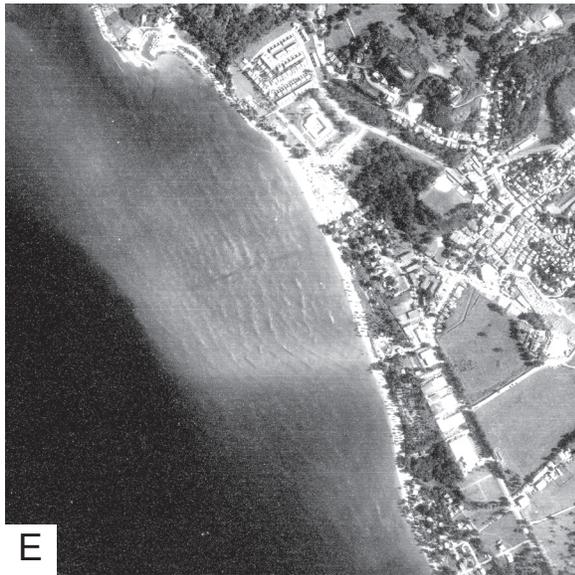
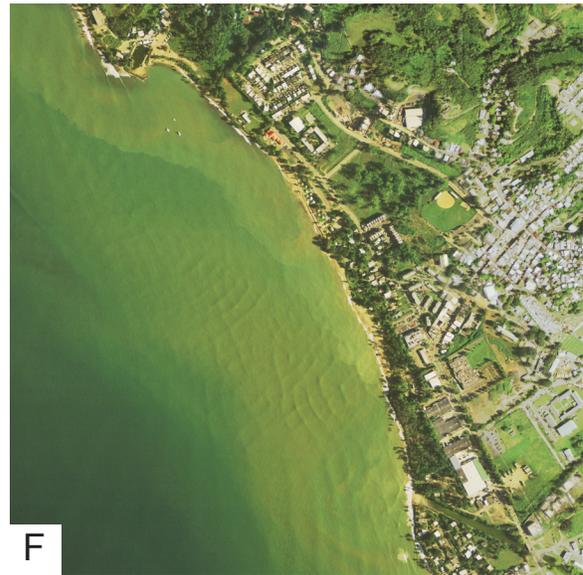
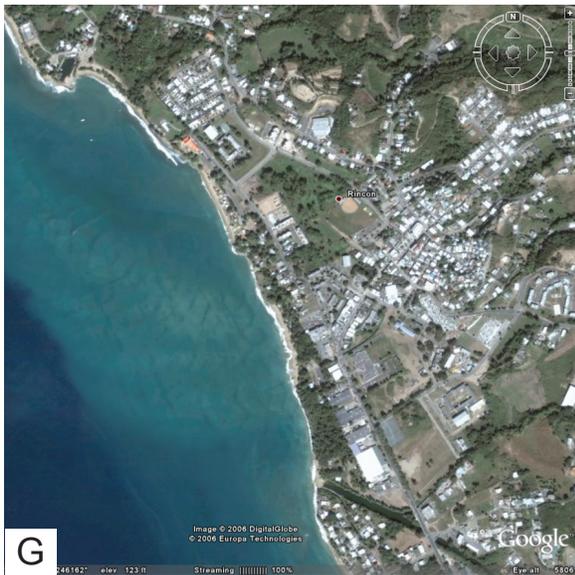
Figure 22. A seven-panel time series of aerial photographs showing complex wave patterns (refraction, reflection, diffraction) in Reach B of the Rincón, Puerto Rico, study area, (A) 14 March 1951, (B) 21 February 1963, (C) 24 December 1963, (D) March 1983, (E) April 1989, (F) 21 September 2004, and (G) undated recent imagery from Google™ Earth (image © 2006 Digital Globe).

Figure 22. A seven-panel time series of aerial photographs showing complex wave patterns (refraction, reflection, diffraction) in Reach B of the Rincón, Puerto Rico, study area, (A) 14 March 1951, (B) 21 February 1963, (C) 24 December 1963, (D) March 1983, (E) April 1989, (F) 21 September 2004, and (G) undated recent imagery from Google™ Earth (image © 2006 Digital Globe). - - Continued

The offshore shoal body appears to exert a substantial influence on the nearshore wave energy in Reach B-2. As shown in figure 22, historical aerial photography shows a very complex pattern of reflected, refracted, and diffracted waves in this area that is not present in the other coastal reaches. This pattern was present at least periodically during large wave events since at least 1951, and could be a long-term feature of the nearshore oceanography of this region. It is unclear what impact on shoreline change such complex wave patterns and associated sediment transport may have. The spatial and temporal association of the wave patterns and shoreline change history, however, suggests a possible, albeit unknown, linkage. It is possible that physical oceanographic measurements (waves, currents, sediment transport) and modeling studies could provide insight into what linkages may exist here.
