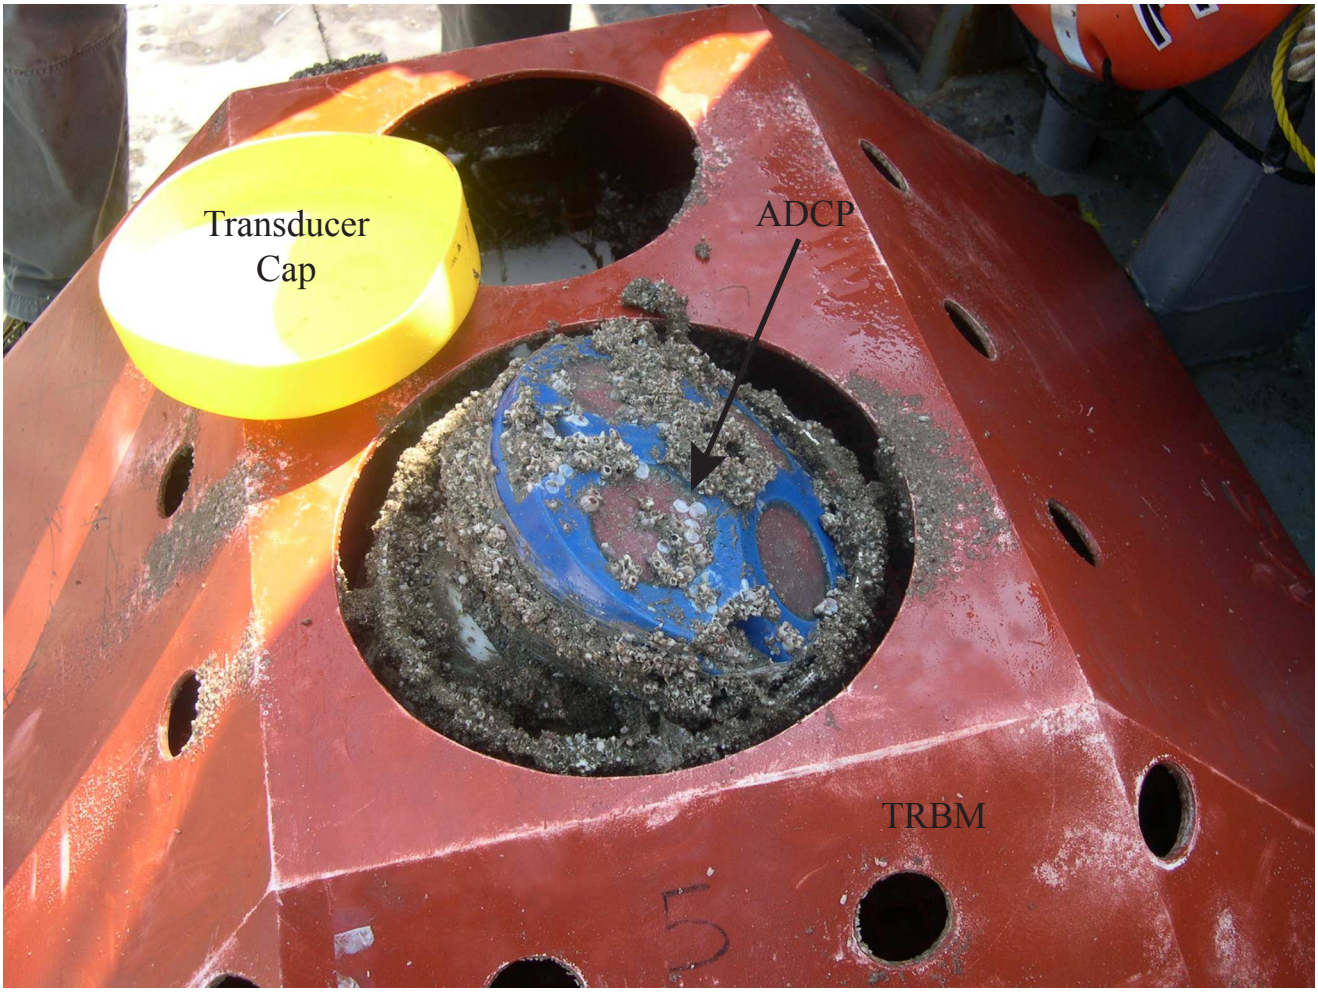
Figure xx. A post-recovery photograph of the ADCP deployed at Site 5. The ADCP was deployed in a TRBM. As seen in this photo, the ADCP became significantly tilted (>25 degrees) while in the TRBM. Data from this ADCP could not be salvaged due to the tilt. Therefore, the data is not included in this report.
