HIGH-RESOLUTION GEOLOGIC MAPPING OF THE INNER CONTINENTAL SHELF: BOSTON HARBOR AND APPROACHES, MASSACHUSETTS

U.S. Geological Survey Open-File Report 2006-1008
Map Sheet 4 - Shaded relief topography of the seafloor colored by backscatter intensity.

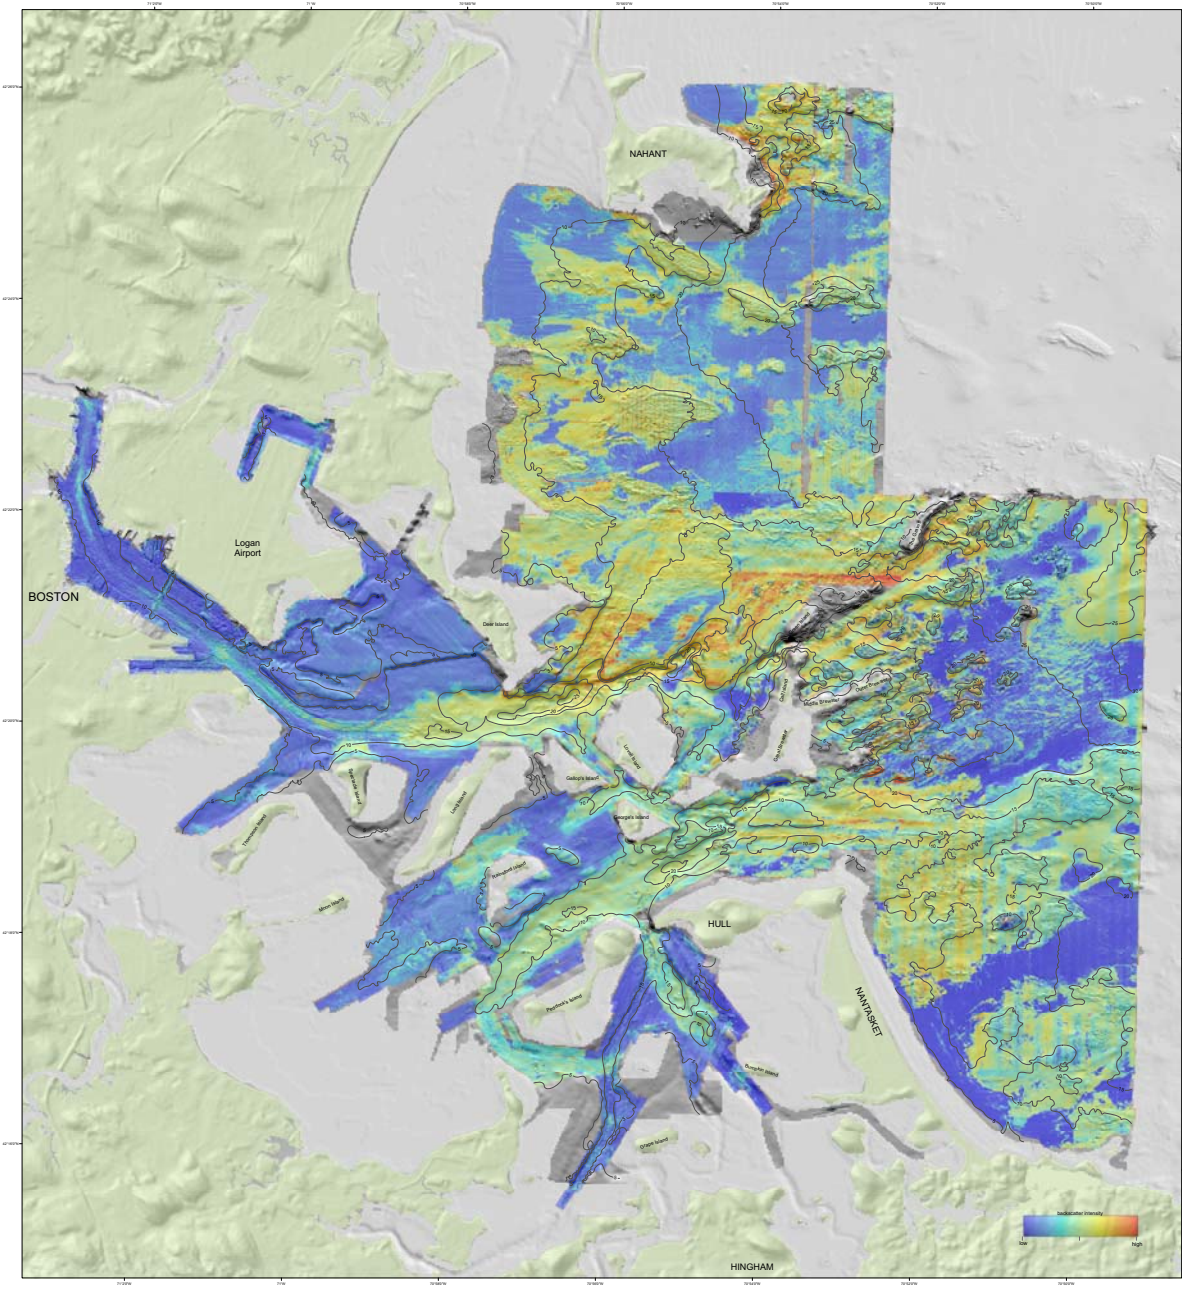
FIGURE 1
Scale: 1:50,000
1 CENTIMETER ON THE MAP EQUALS 100 METERS ON THE SEAFLOOR

BATHYMETRIC CONTOURS IN METERS BELOW MEAN LOWER LOW WATER (MLLW)

The shaded-relief bathymetric maps (sheets 1 and 2) were created by vertically exaggerating the sea floor topography by 10 times and artificially illuminating the sea floor by light source positioned 45° above the horizon from an azimuth of 0° (due north). Topographic features, such as channel boundaries or submarine ridges, are enhanced by strong illumination from the horizon. The bathymetric maps were created by vertically exaggerating the sea floor topography by 10 times and artificially illuminating the sea floor by light source positioned 45° above the horizon from an azimuth of 0° (due north). Topographic features, such as channel boundaries or submarine ridges, are enhanced by strong illumination from the horizon.

Some artifacts are present within the data. These include small high and low, and unusual-looking patterns oriented parallel or perpendicular to survey tracklines. Artifacts may be due to environmental conditions or small boat data collection and processing. Tracklines were generally not parallel to the channel in Boston Harbor and around the Harbor Islands. They were predominantly north-south in the harbor approaches. Slight meandering in the gray-scale lines in the sidescan-sonar (sheet 3 and 4) are also artifacts of data collection and processing. These occur where acquisition parameters in one swath are different from the adjacent swath, making it difficult to match the gray-scale line along the entire length of those lines. Areas that could not be interpreted because they were too shallow (typically less than a few meters deep) are shown in light gray.

Low backscatter intensity material covers most of the Inner Harbor, representing fine-grained sediments (sheets 3, 4 and 5). Moderate backscatter intensity occurs in the shipping channel east of Castle Island and in the northern part of the Inner Harbor east of Boston. The cover of the Ted Williams tunnel is moderate backscatter. The finest sediments sampled in the survey at the mouth of the Mystic River, contained over 40% clay.

The Approaches to Boston Harbor are characterized by areas with rough topography (sheet 1 and 2), elevated sea floor and high backscatter intensity (sheet 3 and 4), and areas of smooth topography and low backscatter intensity. The high backscatter intensity areas are typically covered by outcropping rock, boulders, and cobble. The low backscatter intensity areas are typically covered by fine-grained sediments. The sea floor in Nahant Roads and in the North and South Channels is characterized by low backscatter intensity and is covered by fine-grained sediments. The sea floor in Nahant Roads and in the North and South Channels is characterized by low backscatter intensity and is covered by fine-grained sediments. The sea floor in Nahant Roads and in the North and South Channels is characterized by low backscatter intensity and is covered by fine-grained sediments. The sea floor in Nahant Roads and in the North and South Channels is characterized by low backscatter intensity and is covered by fine-grained sediments.
